Home Inspection Report

260 , F, TN 37328

Thursday September 27, 2018

True Safe Home Inspections
11 Greenhouse Ln
Elora, TN 37328
(256) 527-2959

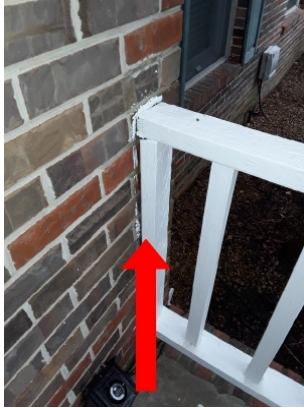
Handrail is loose needs to be secured to house

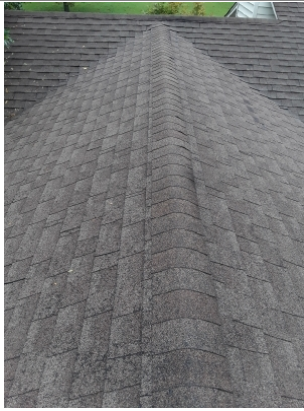
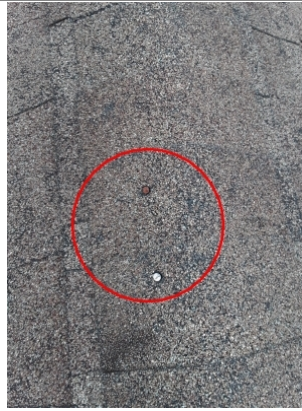
Nail pops need to be repaired
over carport section oh house

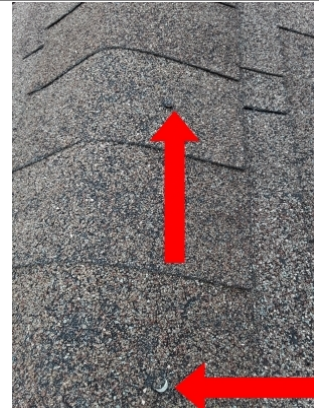
Have nail pops driven back in and
sealed with premium roof caulk
Over carport

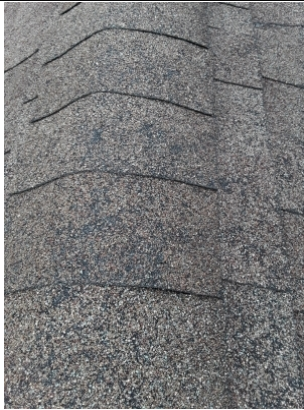
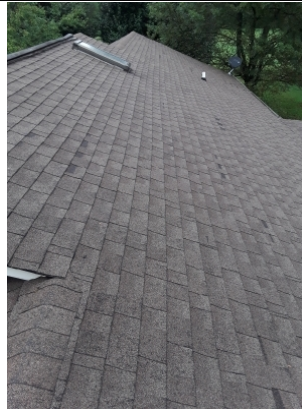
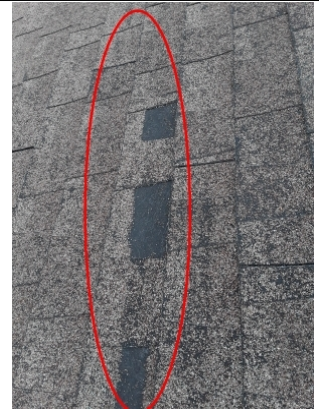
Several granuals missing and
burnt spots

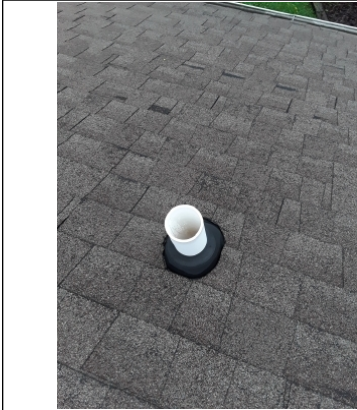
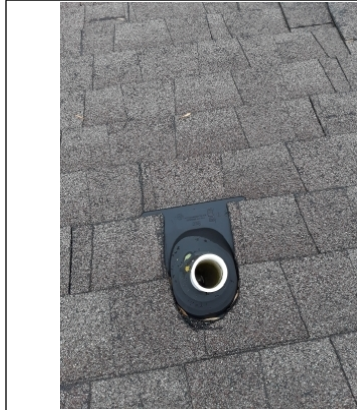
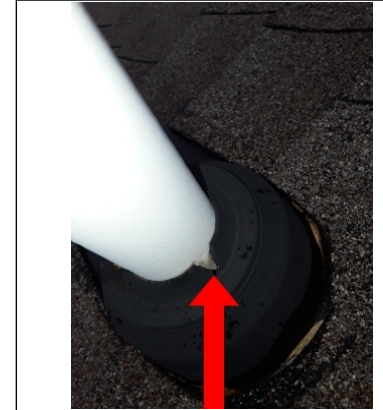
Crack in plumbing boot needs to be replaced

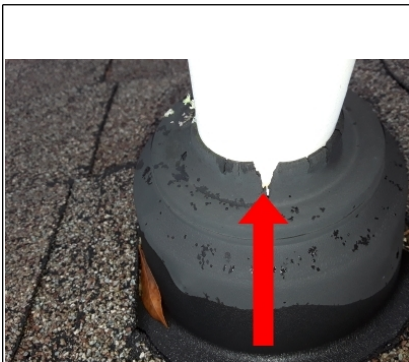
Crack in plumbing boot needs to be replaced

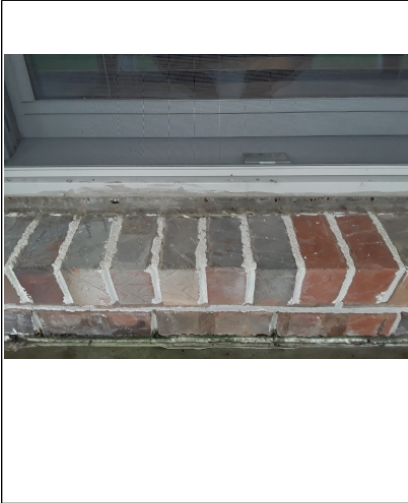
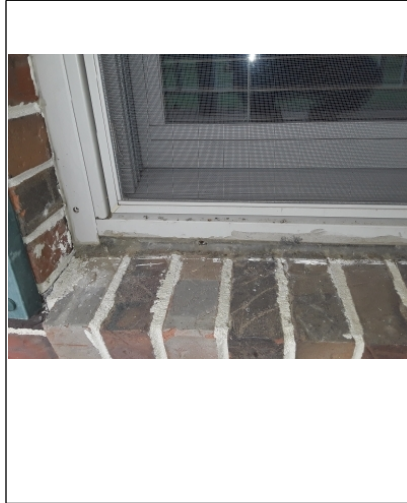
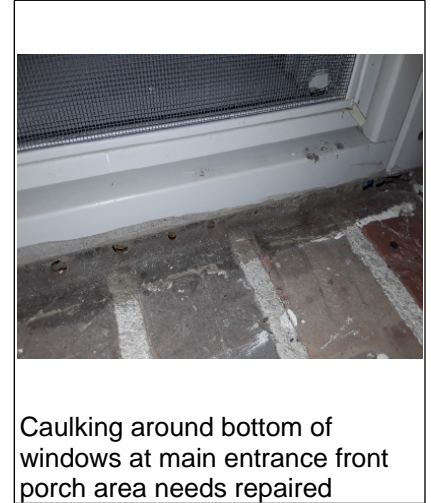
Comments Caulking around bottom of windows at main entrance front porch area needs repaired
 -Copy:

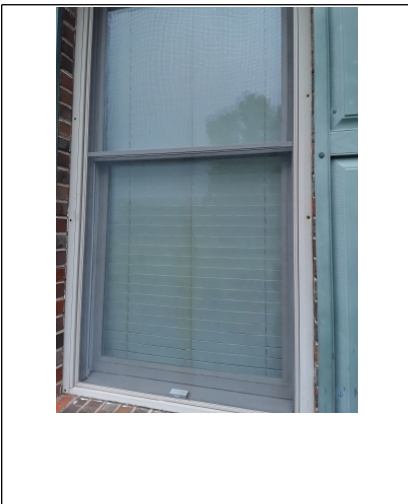
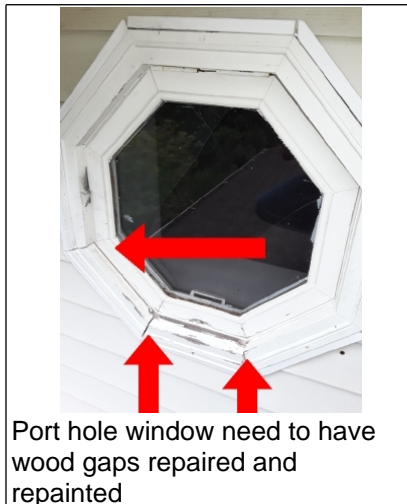
Comments Port hole window need to have wood gaps repaired and repainted

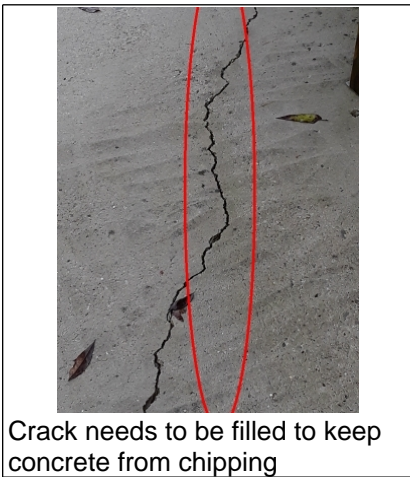
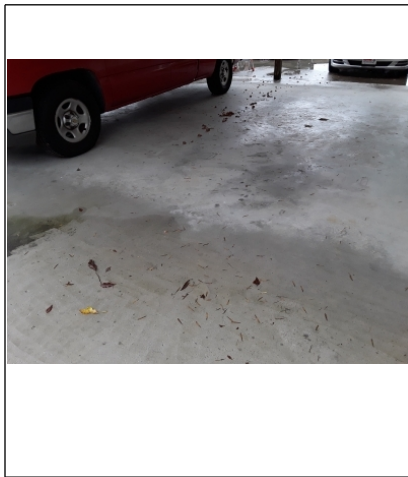
Comments Crack needs to be filled to keep concrete from chipping

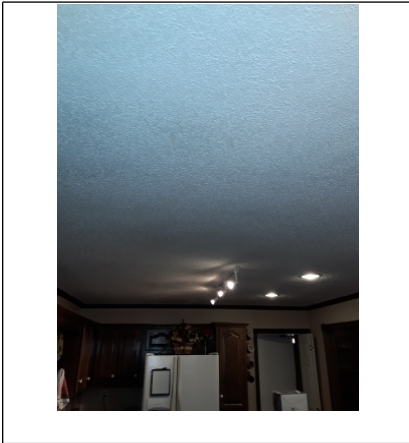
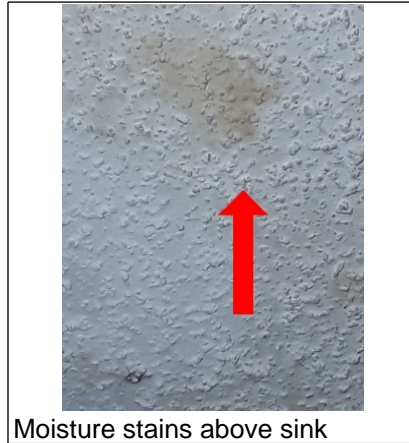
Comments Old water stain above kitchen sink

Moisture stains above sink

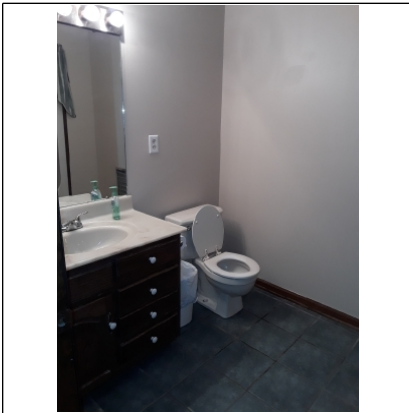
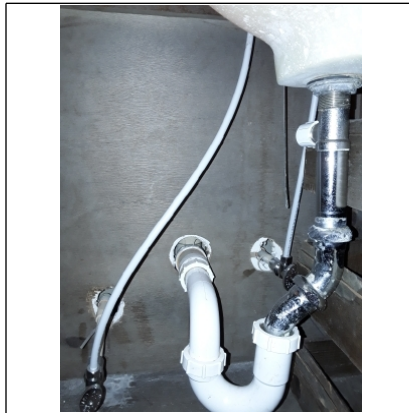
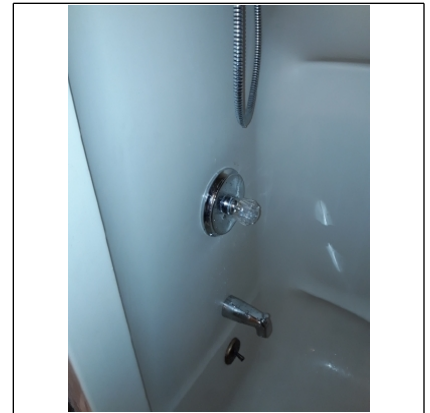
Comments Mixing valve is loose pipes need to be strapped inside wall

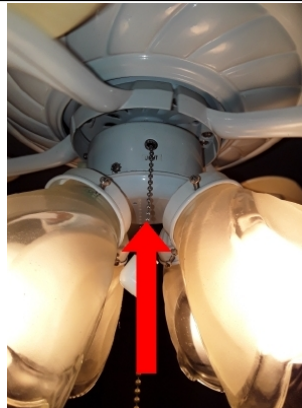
Light switch has been pulled out of fan need to be repaired

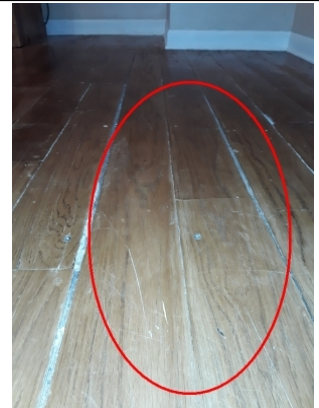
Floor is bowed and has gaps in wood looks like it has been wet before

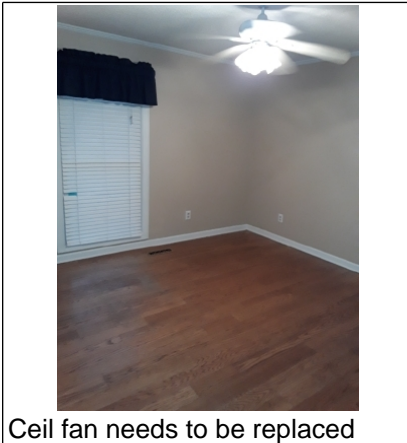
Comments Need to replace ceiling fan in bedroom 2

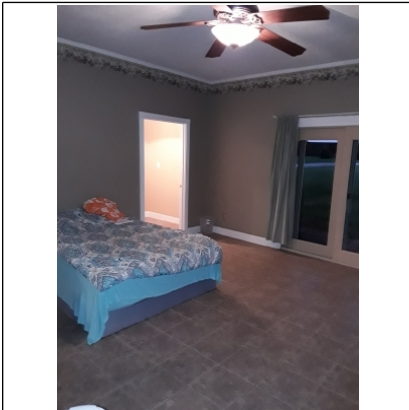
Comments Moisture stains in ceiling above windows
Hole in south wall needs to be repaired

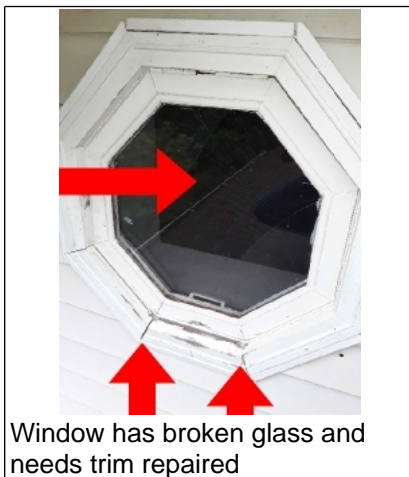
Comments Need to replace window in upstairs room

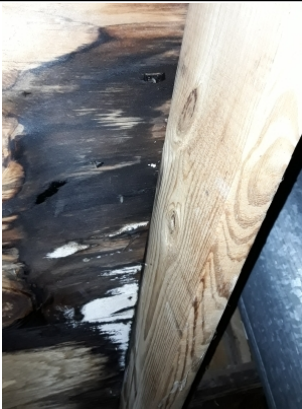
Wet roof decking above bonus room need to repair roof leak

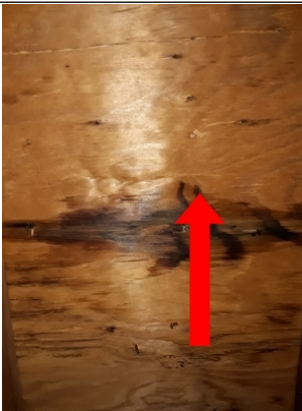
Wet roof decking above master bedroom need to repair roof leak

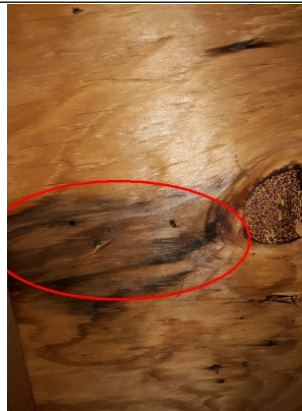
Wet roof decking above bonus room need to repair roof leak

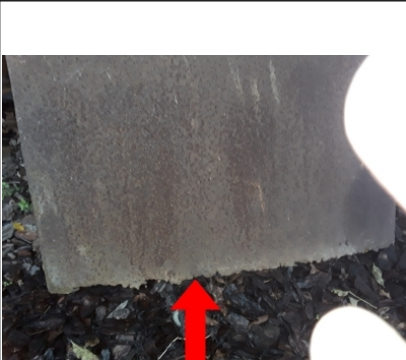
Crawl space door is rusted and missing metal at bottom needs to be replaced

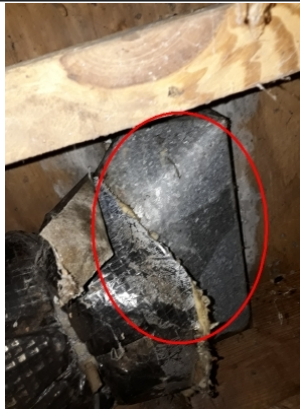
All Hvac duct boots need to be insulated

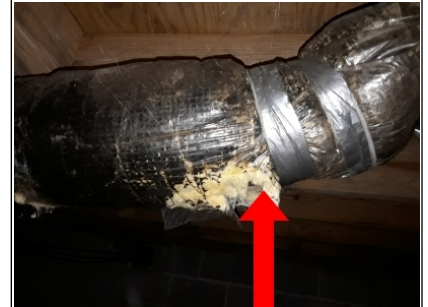
Flex duct needs to be replaced or repaired

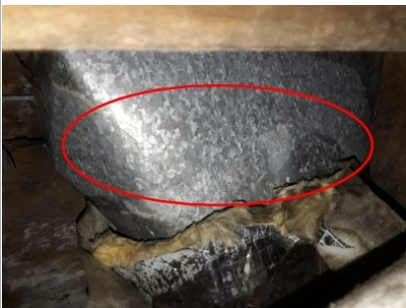
Hvac duct boot missing insulation

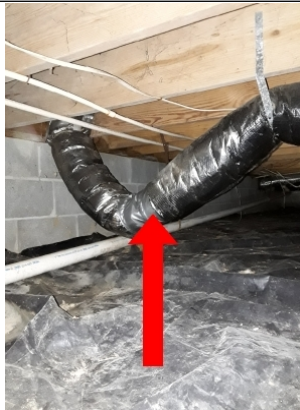
Flexduct needs to run as straight as possible for maximum air flow.
Needs to be replaced

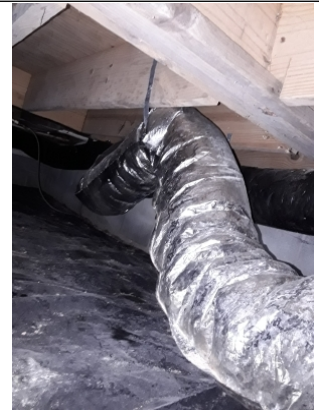
Flexduct needs to be straightened

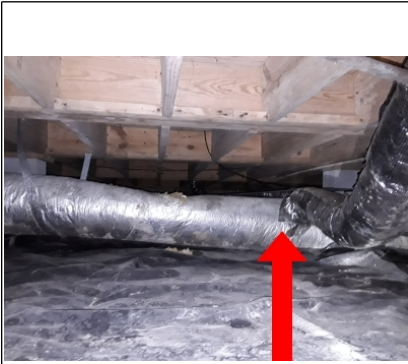
Main supply duct needs to be elevated off the ground straps are broken

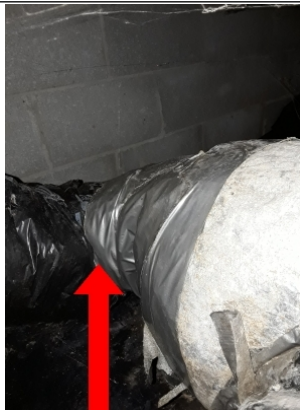
Installed incorrect not suppose to tap off the end of main supply duct need to be repaired

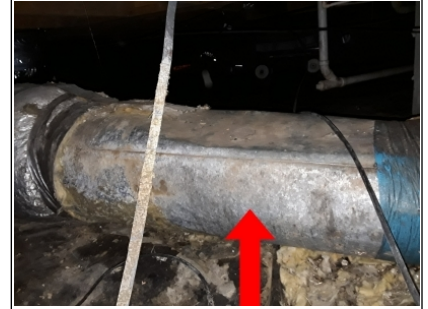
Replace insulation on main supply duct

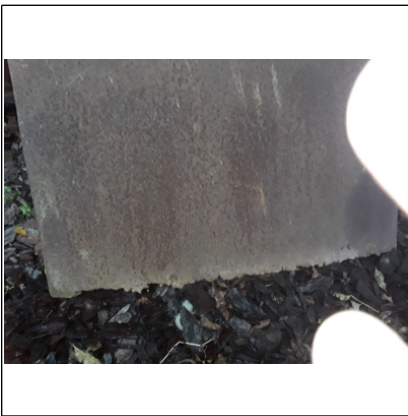
Comments Need to replace crawl space entry door

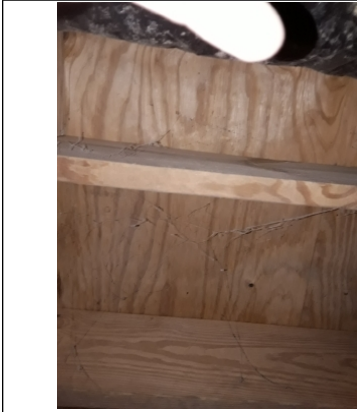
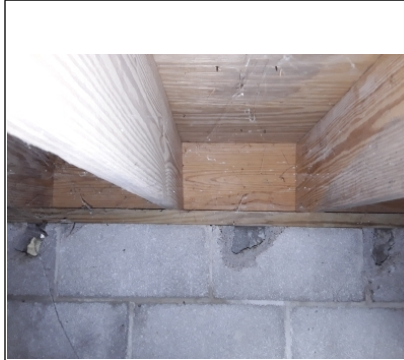
This on the other side of the front porch no damage yet need to caulk between porch floor and brick
