Home Inspection Report

260 , F, TN 37328

Thursday September 27, 2018

True Safe Home Inspections
11 Greenhouse Ln
Elora, TN 37328
(256) 527-2959

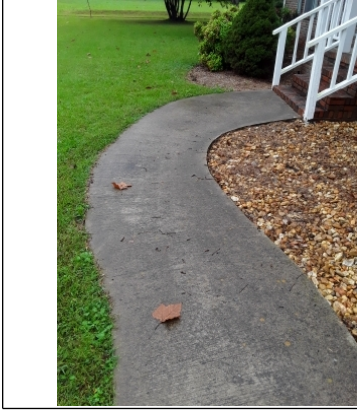
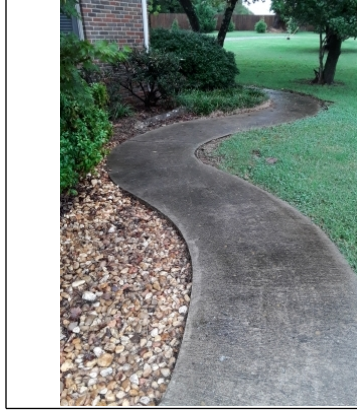
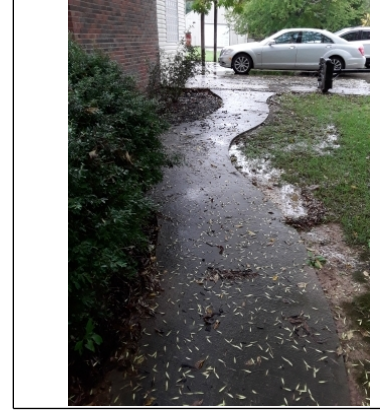
Comments Walkway had some cracking, but is usable.

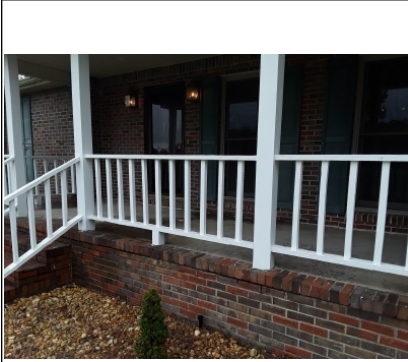
Gap between porch and brick needs to be caulked to keep water from going behind porch

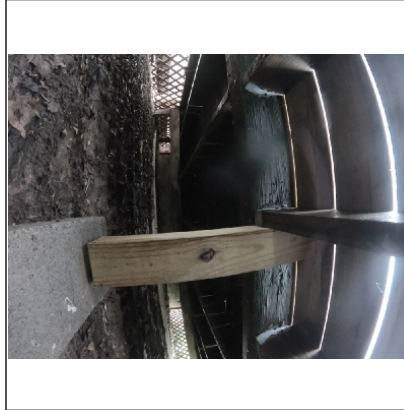
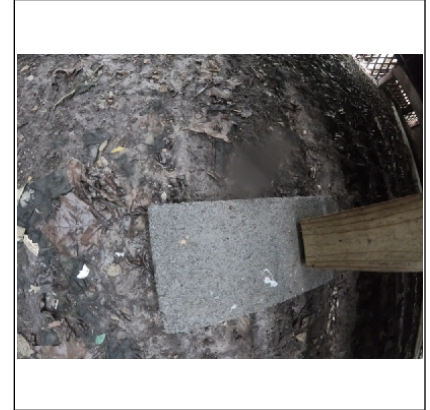
Deck appeared to be in satisfactory condition, applying a sealant on the wood will help prolong the life of the deck.

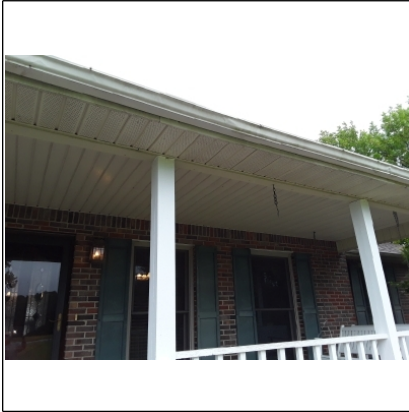
Comments Front porch cover is in good condition

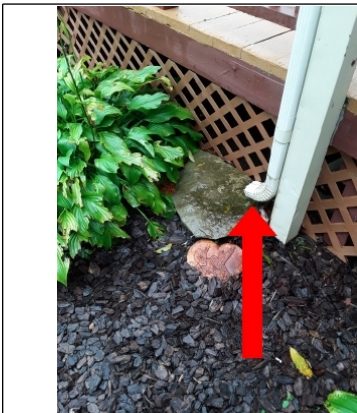
Down spout at pool deck needs to be extended

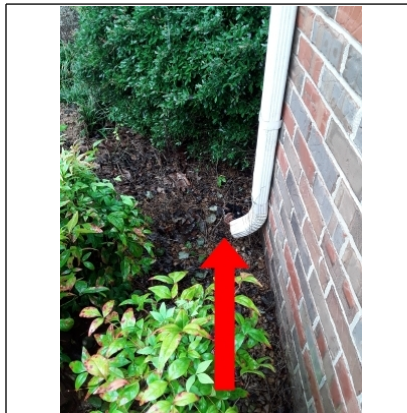
Down spout on front left hand side needs to be extended

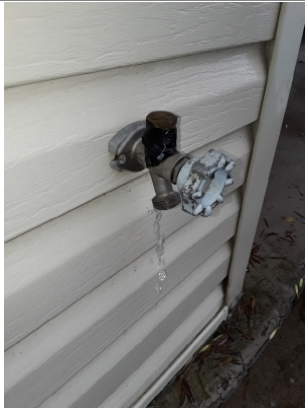
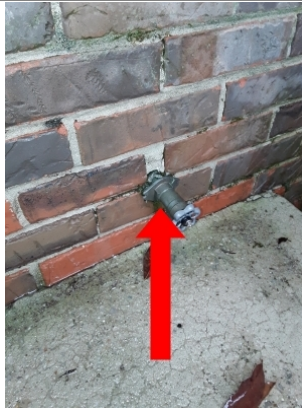
Hose bib needs to be reanchored
to wall

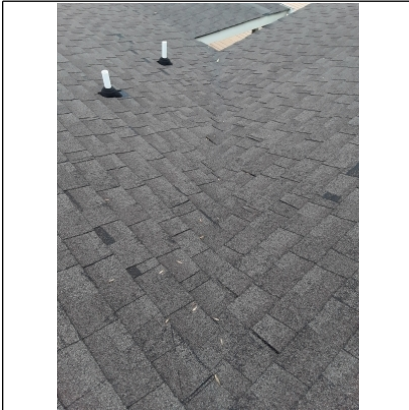
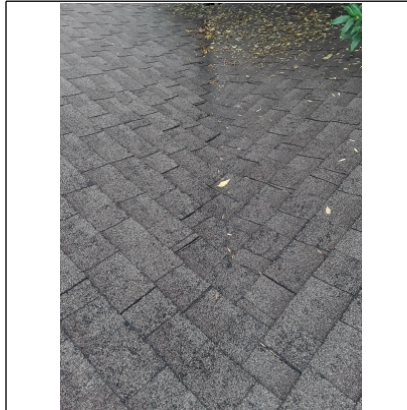
Valleys where in good condition at time of inspection

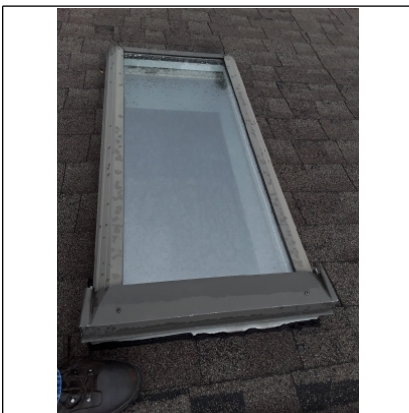
Comments Skylight was in satisfactory condition at time of inspection

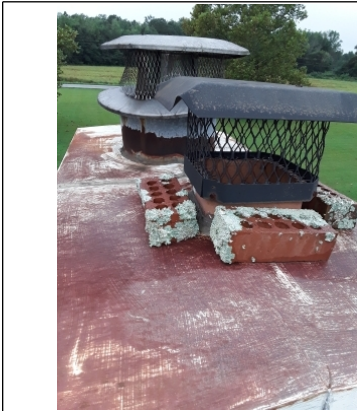
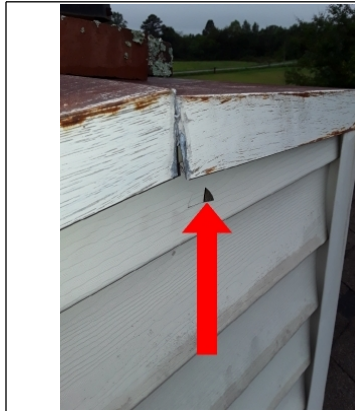
Comments Hole in vinyl needs to be filled on chimney

Hole in vinyl needs to be filled on chimney

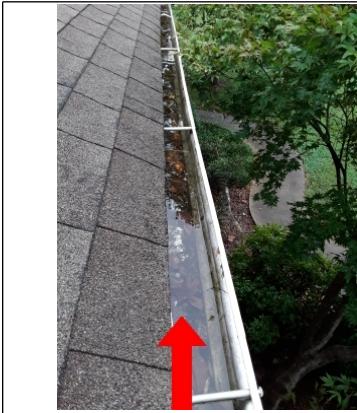
Gutter on right front of house needs to sloped so it will drain properly.

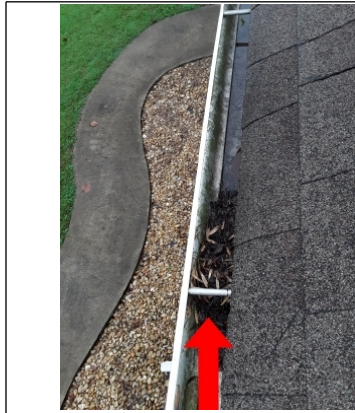
Gutters need to be cleaned

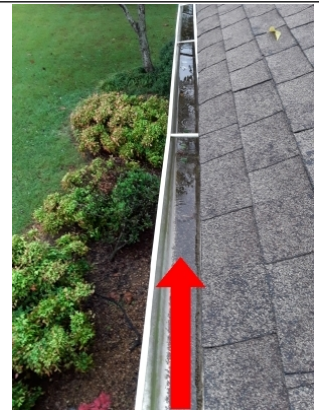
Gutter need to be sloped so it will drain

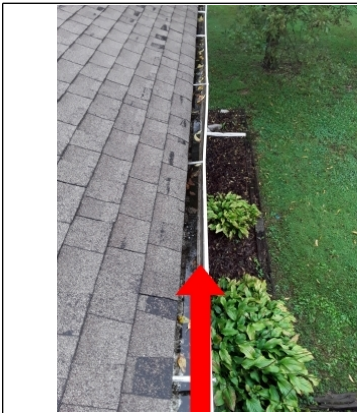
Gutter on back left side needs to be cleaned and aloped so it will drain

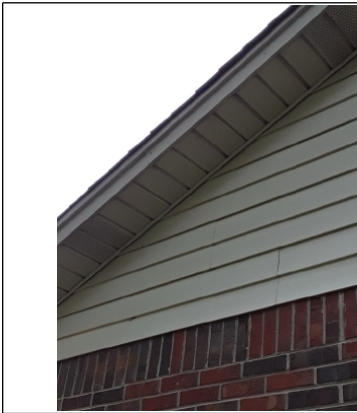
No problems found in soffit at time of inspection

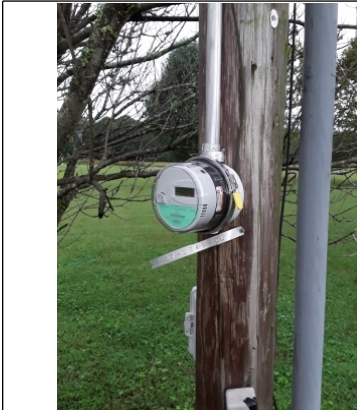
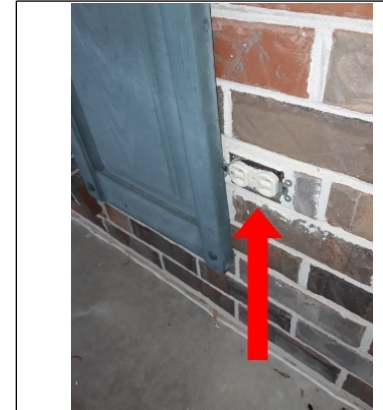
Comments Front porch plug needs to have weather proof cover installed and needs to be changed to a GFI outlet

Front porch plug needs to have weather proof cover installed and needs to be changed to a GFI outlet

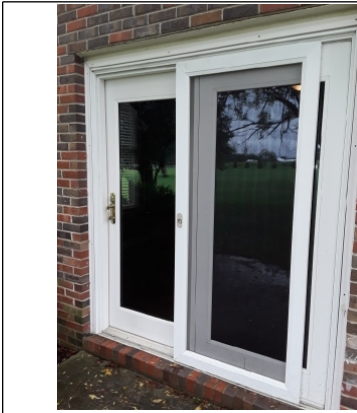
Weather stripping at bottom of door is torn a little

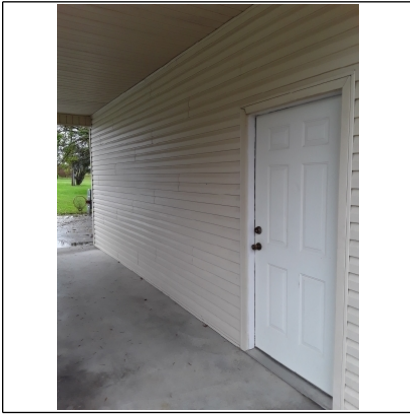
Comments Crack needs to be filled to keep concrete from chipping

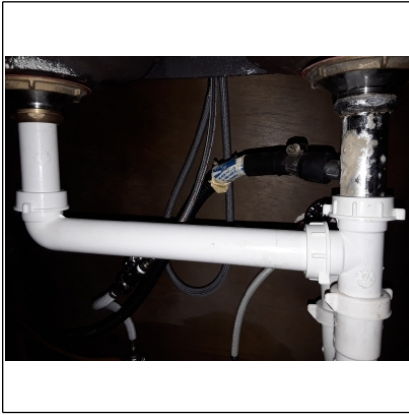
Comments Old water stain above kitchen sink

Moisture stains above sink

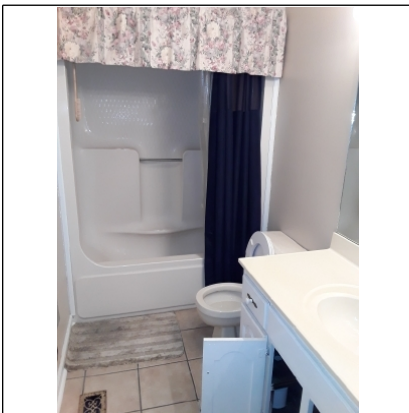
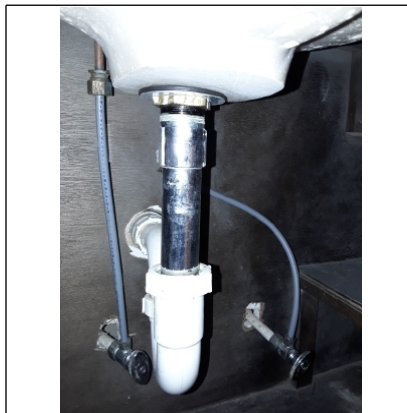
Comments Drainage was a little slow at sink and shower

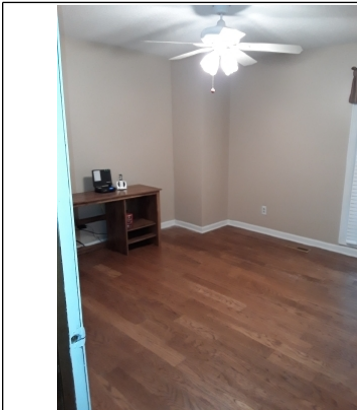
Comments Floor is bowed and has gaps in wood looks like it has been wet before
Light switch has been pulled out of fan needs to be repaired bedroom 1

Light switch has been pulled out of fan need to be repaired

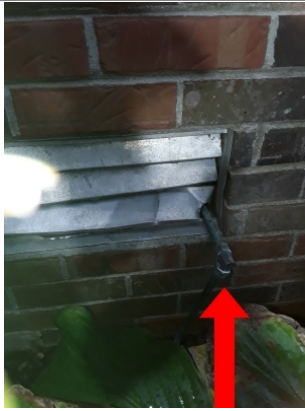
Gas line needs to ran through brick and not wall vent need to install correct

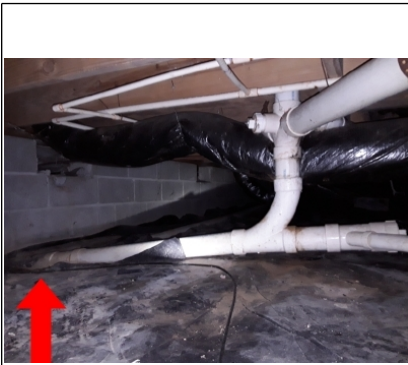
Main drainage exits rear of house and left of deck

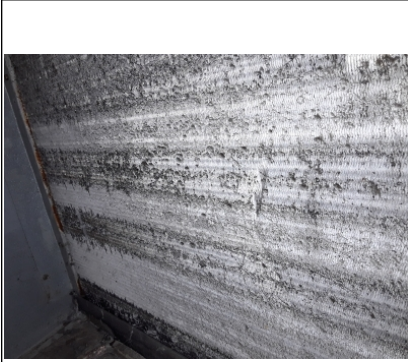
Evaporator coil ☐ Satisfactory ☐ Not Visible ☒ Needs cleaning ☐ Damaged

Condition ☐ Satisfactory ☒ Marginal ☐ Poor ☐ Recommend HVAC technician examine/clean/service
☐ Not operated due to exterior temperature

Evaporator coil needs cleaning

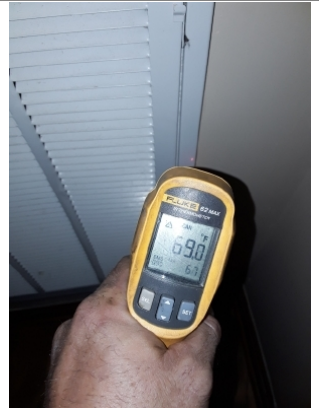
Return air temperature
